Aznalcóllar dam failure. Part 1: Field observations and material properties

E. E. ALONSO* and A. GENS*

The paper describes the failure of Aznalcóllar dam, in southern Spain, in April 1998. The rockfill dam slid forward and released a flow of acid-saturated tailings. The geology and geomorphology of the site are described. The results of a detailed laboratory testing programme on the tailings material and on the overconsolidated high-plasticity foundation clay are given. Special attention is paid to the identification of cementation of the tailings and to the strength and consolidation properties of the foundation clay. Failure features are interpreted on the basis of the field evidence, taking into account the measured geotechnical properties of the materials involved.

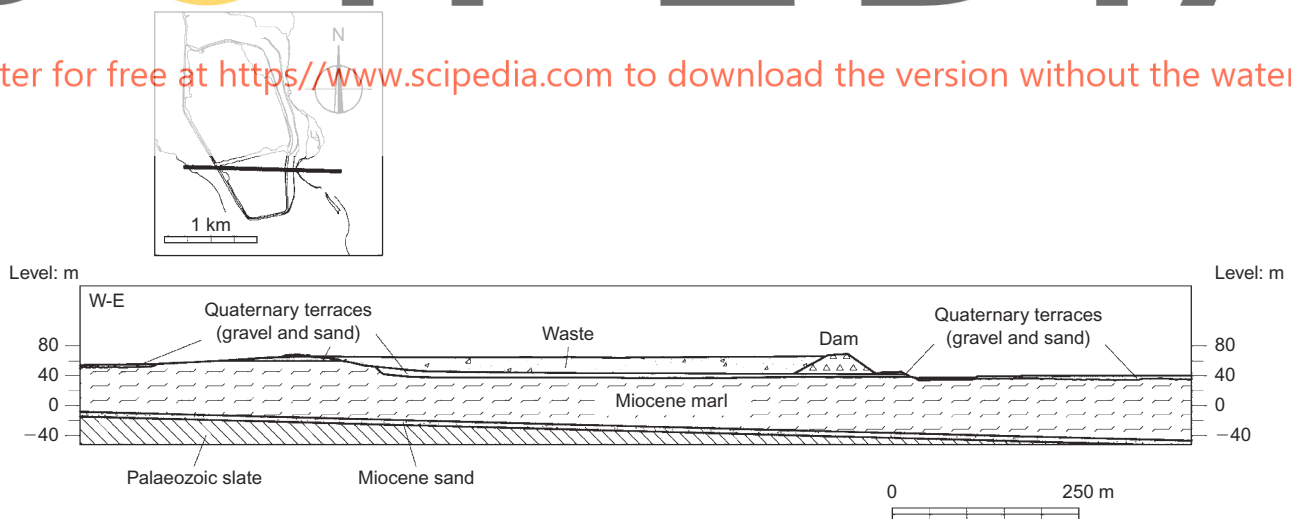
Fig. 5. Cross-section of tailings lagoon. Two stratigraphic discordances are observed: a lower one (high angle) between the Palaeozoic substratum and the upper Miocene deposits, and an upper one (low angle) between the Miocene clays and the Quaternary deposits

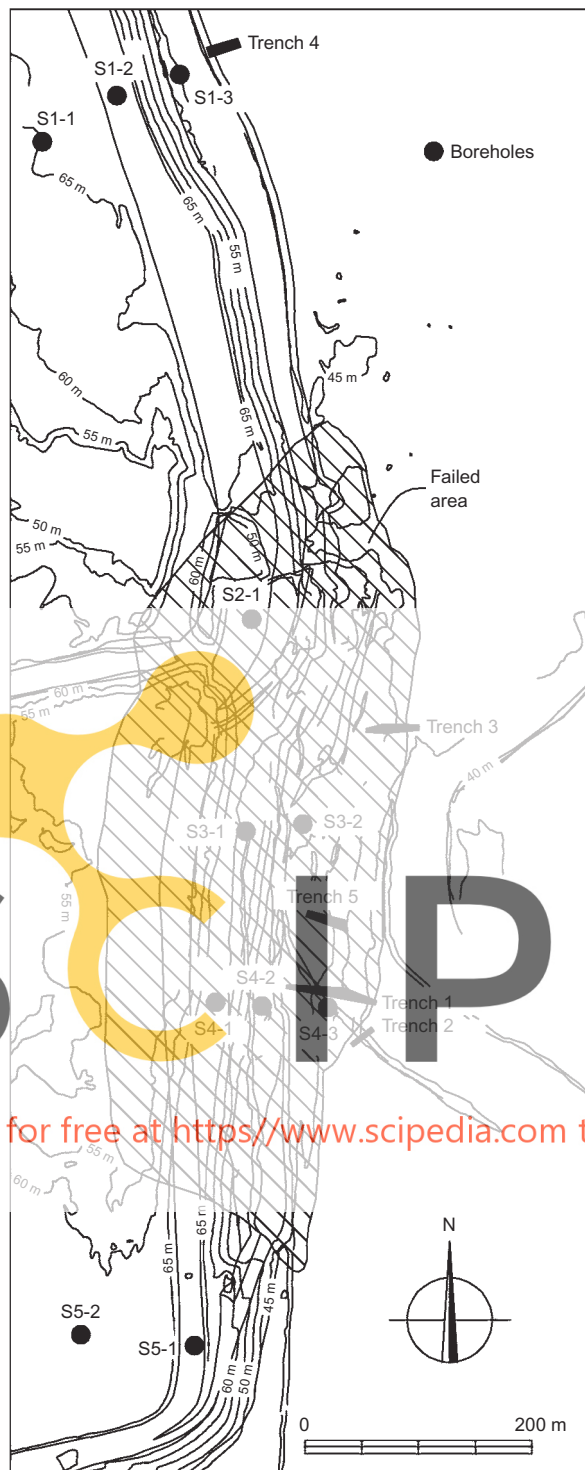
The geological description of the site is based on surface observations and on the interpretation of data provided by rotary-drilled boreholes and shallow trenches excavated after the failure in the locations shown in Fig. 6. The displaced area of the embankment, which affected the south-east part of the lagoon, is also shown in Fig. 6. Details of the slide, which was the ultimate cause of the dam failure, are given later.

Fig. 6. Location of field investigation boreholes and trenches performed after failure. Displaced area also shown (cross-hatched).

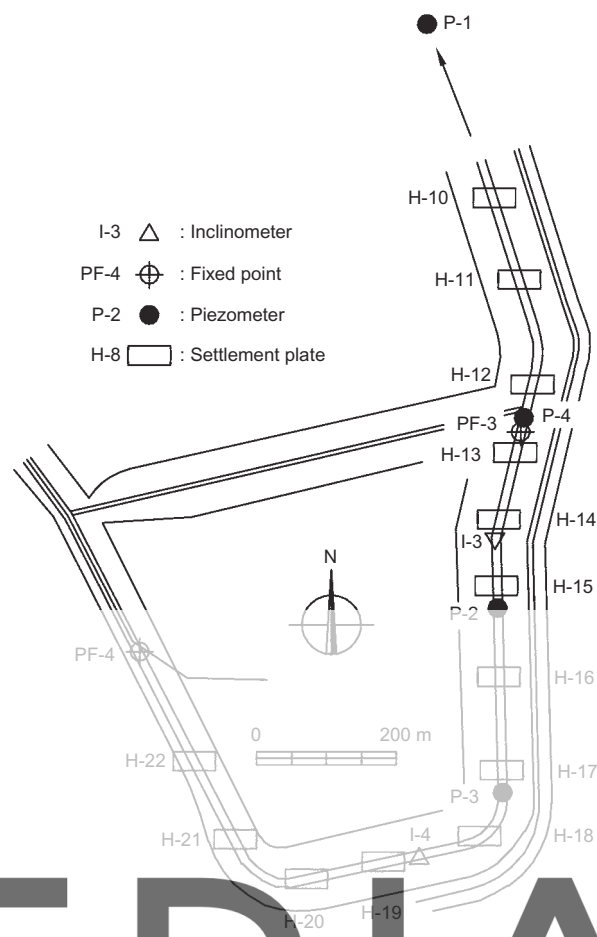
Following the recommendations of an evaluation, in 1996, of the dam safety, a monitoring programme was set up. Fig. 13 shows, in plan view, the position of the instruments in the length of the embankment later affected by the failure. Settlement plates, piezometers (in fact observation wells) and a few inclinometers were located along the crest of the embankment (a few fixed points, shown as PF in Fig. 13, were used as a reference for plate levelling). Great significance was assigned to piezometer readings, and a safety procedure was established in the event of piezometers indicating a rise in water pressure or in the case of abnormal outflow. The ‘piezometers’ were slotted open tubes penetrating 2 m into the foundation clay. It is clear that they were not intended to measure pore water pressures in the clay, but rather any water pressures developing in the granular alluvium or in the pervious rockfill.

Fig. 13. Position of monitoring instruments: south-eastern side of Aznalcóllar dam

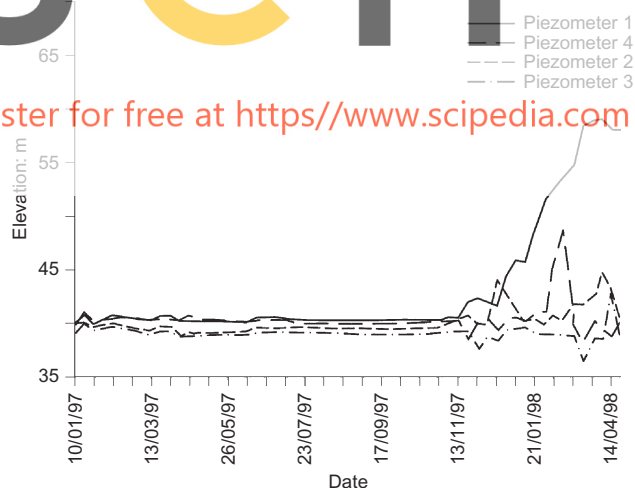
The recorded water heights of the open tube piezometers P-1, P-2, P-3 and P-4 are shown in Fig. 15. The behaviour is fairly regular during the first 10 months of 1997 and the

Fig. 15. Evolution of water elevation in piezometers P-1, P-2, P-3 and P-4

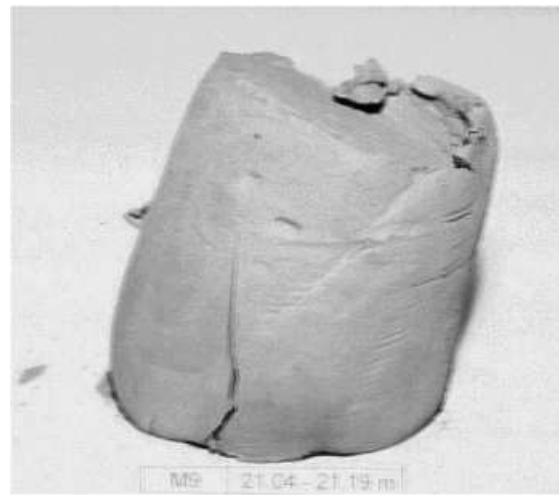
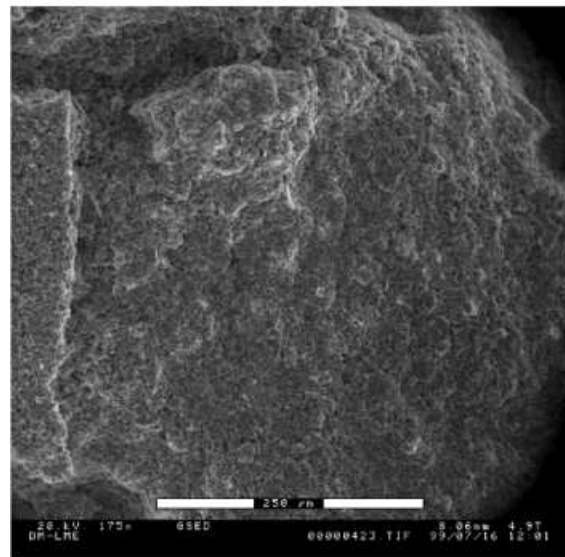
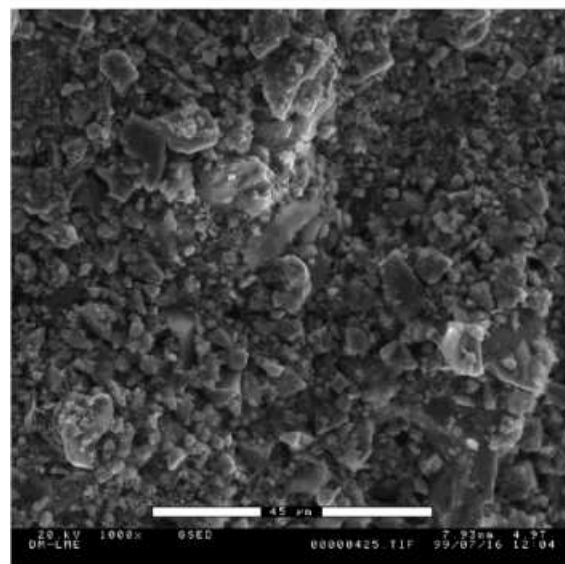
Fig. 26. (a) Specimen of pyrite tailings after triaxial testing; (b) view at $\times 175$ scale; (c) view at $\times 3000$ scale

response and a rapid generation of pore pressure, indicating a collapse of the granular structure. However, as failure conditions were approached, a strong dilatancy changed the trend of pore pressure generation, and the path followed the strength envelope at increasing effective confining stress. When the test was stopped, at very large strains (24%), positive pore pressures were again recorded, although they may not be very significant in view of the large strains reached. Failed specimens, especially those coming from the pyritic lagoon, showed distinct shear planes.

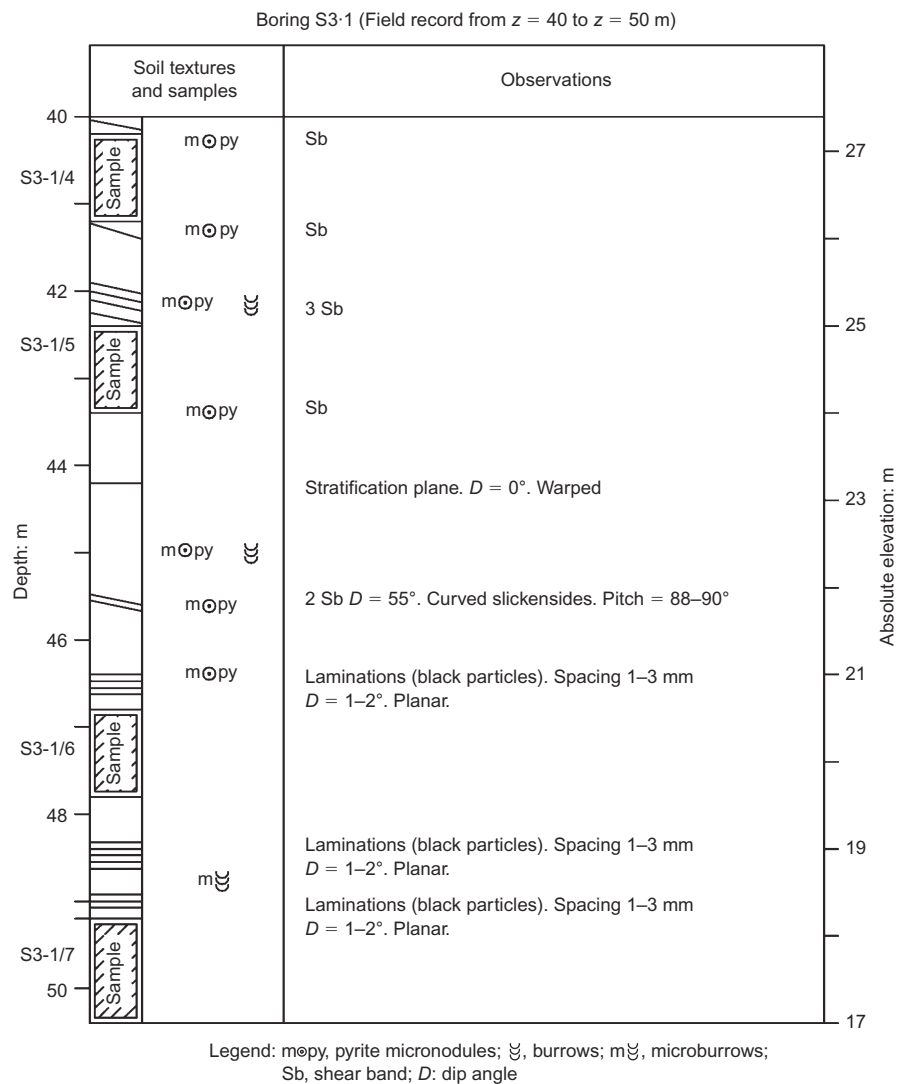
It was decided to test in some detail two 'soil columns': boreholes S3-1 and S4-1 located in the slide area (Fig. 6). These two boreholes encountered first the embankment rock-fill, then the alluvial layer and finally the blue clay. The detailed stratigraphy of a portion of the blue clay, from borehole S3-1, is shown in Fig. 33. The sliding plane was estimated to be located at elevations 26–27 m. In one location a warped bedding plane was identified. Subhorizontal laminations (dip $1-2^\circ$) presumably parallel to bedding planes were also observed. Shear bands were also detected at non-regular intervals. They are often inclined at a significant angle. Pyrite micro nodules are scattered throughout, often showing linear arrangements parallel to bedding or lamination planes.

Fig. 33. Portion of stratigraphic column of borehole S3-1 between depths $z = 40$ m and $z = 50$ m (location of borehole shown in Fig. 6)

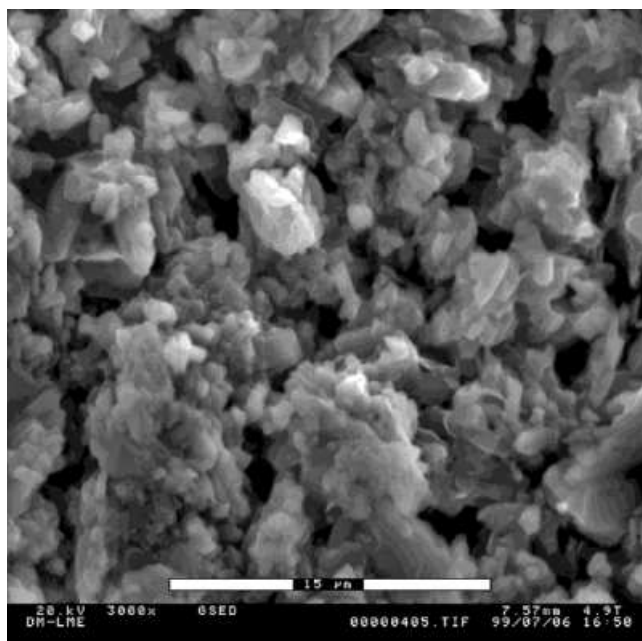
Scanning electron microscope observations were made on intact samples (by examining a surface induced by a tension failure) and on sheared surfaces. In all cases the clay minerals were seen to occur in aggregates of irregular ellipsoidal shape, having sizes of 5–10 μ m (Fig. 35). Weathering (brownish colours) results in a more marked aggregate structure. Tsige (1998) found that the weathered clay had an

Fig. 35. SEM microphotograph (×3000) of a discontinuity surface of the blue clay

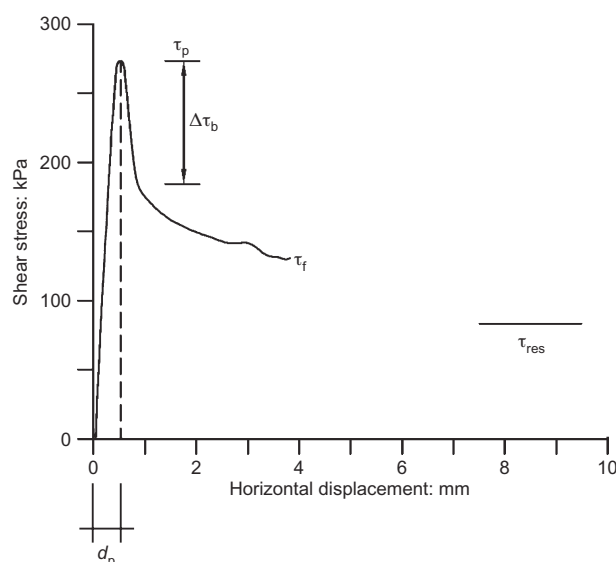
- (a) All the specimens exhibited a brittle behaviour. Peak strength was found for displacements of 0.5–1.5 mm (for a range of vertical stresses of 100–400 kPa). Beyond peak the strength initially drops rapidly, then more gradually. This behaviour is illustrated in Fig. 36 for one of the specimens tested. This behaviour will be described by the following parameters: peak strength, τ_p ; displacement to reach the peak, d_p ; strength at the end of the test (for a displacement of 4–6 mm), τ_f ; rapid drop of resistance post-peak: $\Delta\tau_b$. An additional reference strength, the residual strength τ_{res} , may be calculated for a given vertical stress once the residual friction angle is known. As shown later, a representative value $\phi'_{res} = 11^\circ$ was found for this clay. Two brittleness indices are used: $I_f = (\tau_p - \tau_f)/\tau_p$ and $I_B = (\tau_p - \tau_{res})/\tau_p$. I_B is the definition proposed by Bishop (1967). It is clear that $I_B > I_f$. In addition, a measure of the rapid loss of strength after the peak is given by the cementation loss indices, $CL_f = \Delta\tau_b/(\tau_p - \tau_f)$ and

Fig. 36. Direct shear test on specimen of foundation clay from sample M3, borehole S3-1 (depth 39.20–40.1 m): normal effective stress 400 kPa

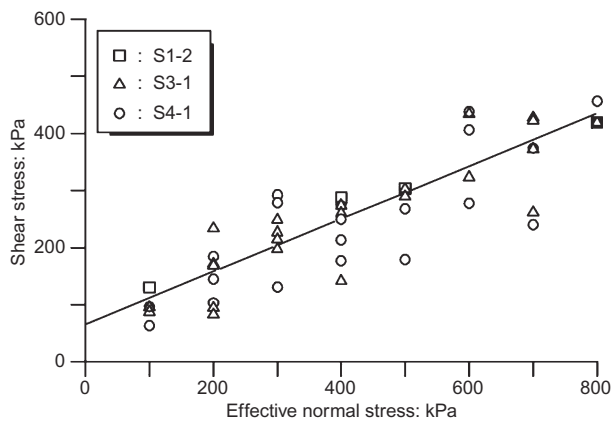
Fig. 41. Drained peak strength envelope for Guadalquivir blue clay

strength on horizontal planes corresponds to the clay matrix. Measured peak strengths are plotted in Fig. 41 in a Coulomb diagram. Some scatter is observed. Average peak strength values correspond to the drained parameters $c' = 65$ kPa, $\phi' = 24.1^\circ$. If the strengths measured at the end of the direct shear test (for displacements of 4–6 mm) are considered, an average limiting curve $c' = 0$ kPa, $\phi' = 20^\circ$ is obtained.

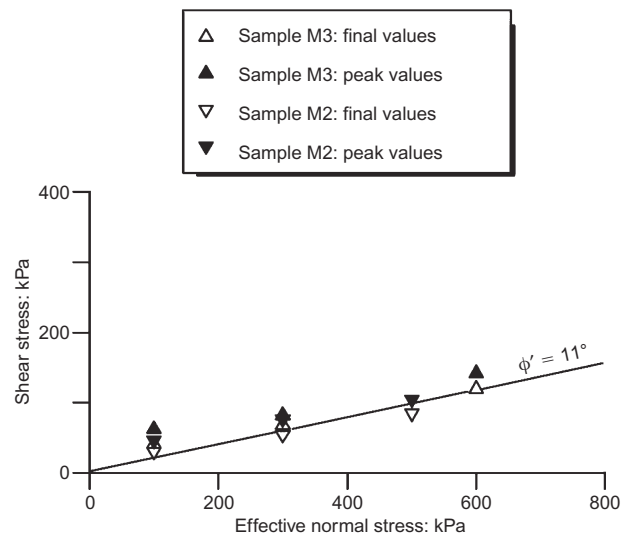
Fig. 43. Summary of direct shear tests performed on two natural discontinuities of the clay

Natural joints found on the large clay blocks deposited by the mudflow (Fig. 12) were tested in the shear box. The discontinuity was aligned with the shearing plane of the box. Several reversing cycles were applied, and displacements in excess of 60 mm were achieved. For vertical stresses in the range 200–400 kPa a friction angle $\phi'_{res} = 11^\circ$ was found (Fig. 43).

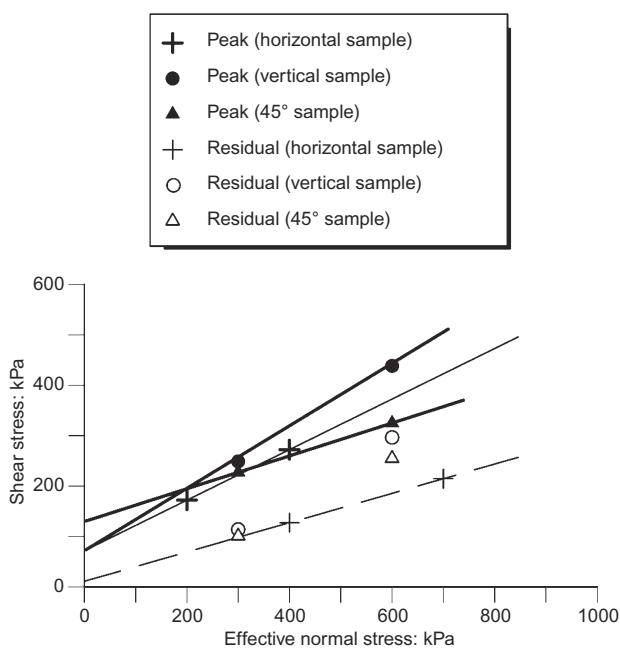
Fig. 42. Shear strength measured in inclined samples of foundation clay

- (e) Several specimens were tested along planes inclined at 45° and 90° with respect to the horizontal. The results are collected in Fig. 42. No clear indication of anisotropy of the clay matrix was found, so it is possible that peak parameters determined for horizontal shearing may represent average peak strength.

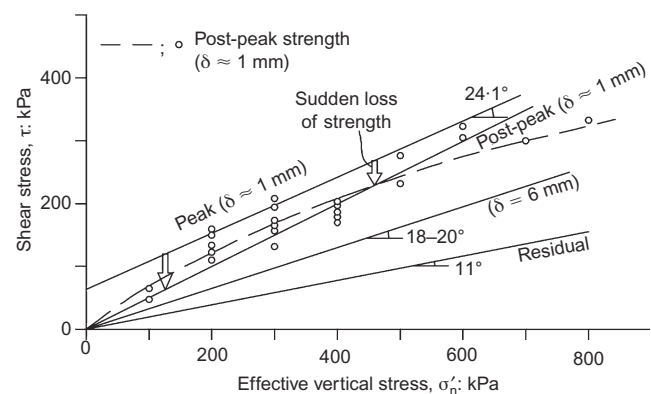
Fig. 44. Direct shear strength envelopes of foundation clay

The results of all direct shear tests performed on horizontal planes are summarised in Fig. 44. The average peak strength is obtained for a shear displacement of 1 mm. The open symbols in the figure correspond to the strength measured immediately after the peak at essentially the same displacement. The curved strength envelope is a reasonable approximation to the measured values. A straight line is also fitted to the points. The important result is that the sudden loss of strength results in a destruction of the effective cohesion. An accumulation of shear displacements of 6 mm implies a drop of friction angle down to 18 – 20° . Finally, the residual friction envelope, associated with further additional displacements, is also plotted in the figure.

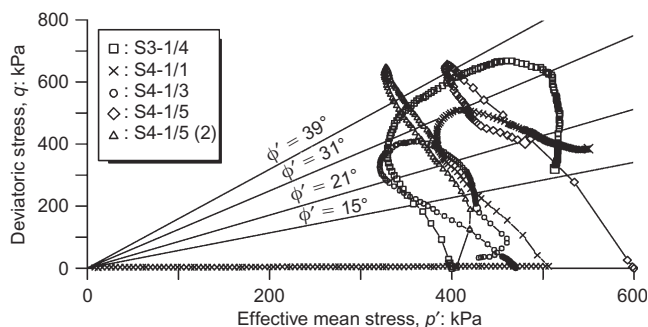
Fig. 45. Stress paths measured in isotropic undrained triaxial tests

Several isotropically consolidated undrained tests were performed in a stress-path cell. Peak strengths correspond to friction angles in the range $\phi' = 31$ – 39° (Fig. 45). For the final conditions (vertical strains in excess of 20%), the friction angle drops to 15 – 21° . The maximum values of Skempton's A -coefficient ($A_{max} = 0.7; 0.45; 0.24; 0.49; 0.8$) reflect a moderate contractant behaviour before the onset of dilatancy. Near the peak some dilatancy develops, and the final A values indicate this change ($A_f = 0.6; 0.35; -0.03$;

0.20; 0.55). The 'elastic' value of $A = 0.33$ is probably a reasonable average value. Elastic moduli measured at relatively low strains ($\epsilon_z = < 2 \times 10^{-3}$) were in the range 55–115 MPa for confining stresses varying from 400 to 600 kPa.
